**Flood Control Project Maintenance
Levee Inspections**

Spring 2012 Levee Inspection Results

Yolo County Service Area 6

Waterway			Bank	Unit Miles
Unit No. 01 Right Bank of Sacramento River at Knights Landing			Right	5.97
	Spring (March - May)	Summer (June - August)	(September - November) Fall	Winter (December - February)
Unit Maintenance Rating (Fall Only)				
Date of Inspection	4/17/2012 - 4/17/2012			
DWR Inspector	John Williamson			
Accompanied By	Regina Espinosa Yolo County			
	Chris Starke Yolo County

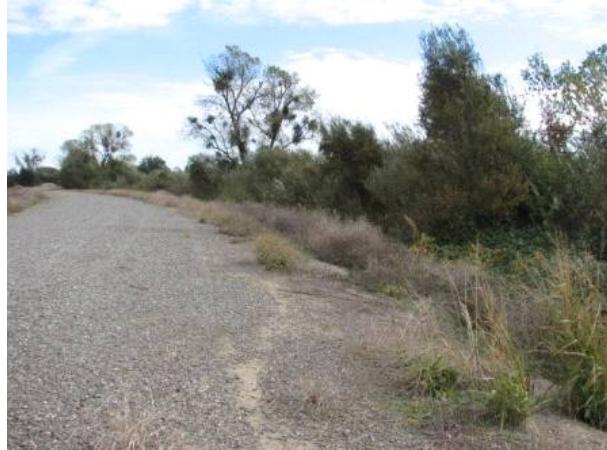
johngw_s_20120313_251.jpg

The vegetation blocks the view of the levee slope.
Fall 2011

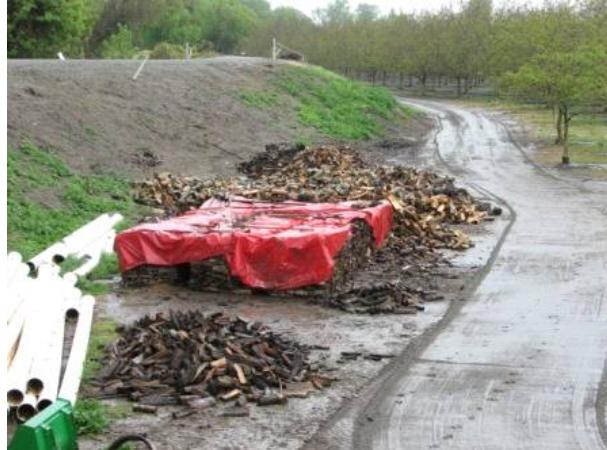
johngw_s_20120313_265.jpg

Firewood stacked up

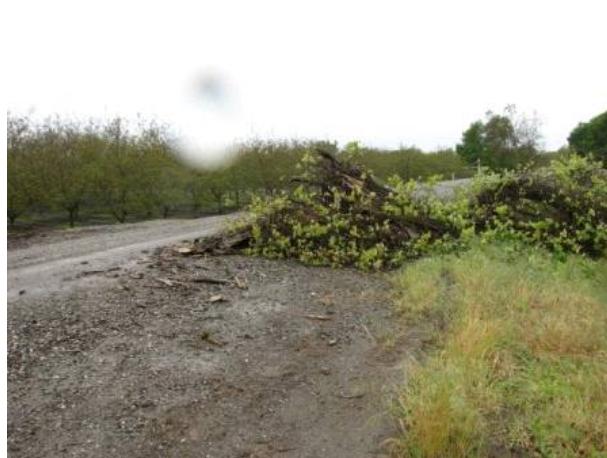
johngw_s_20120313_268.jpg

Tree across levee

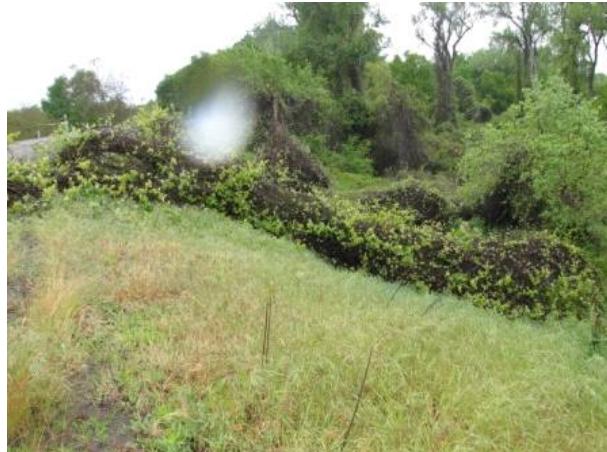
johngw_s_20120313_269.jpg

Water side view.

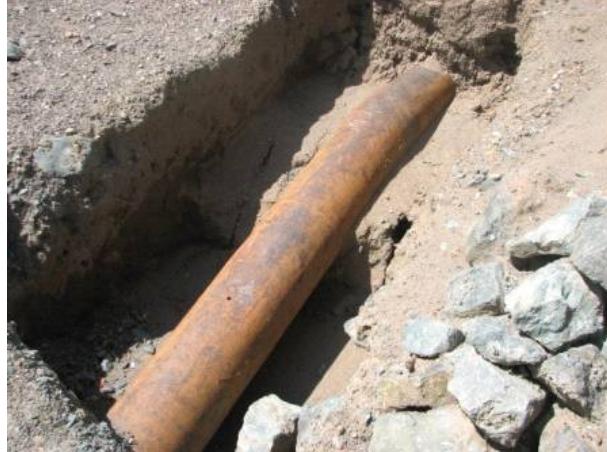
Levee Mile Report Line	43
Start Levee Mile	3.47
End Levee Mile	3.47
Location	Water Side
Category	Earthen Levee
Item	Encroachments
Small hole in the top of pipe.	
<i>johngw_s_20120419_719.jpg</i>

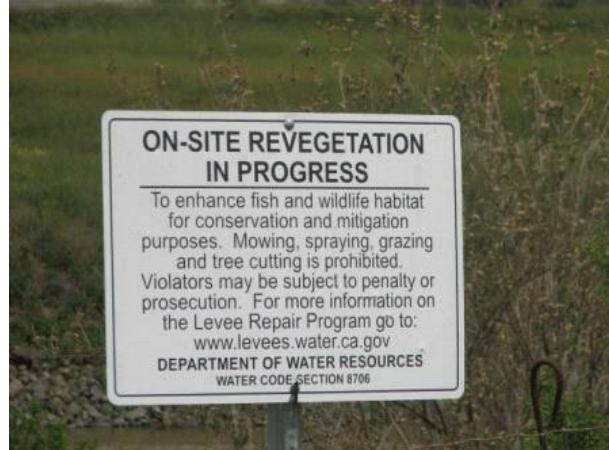
Levee Mile Report Line	45
Start Levee Mile	4.31
End Levee Mile	4.57
Location	Water Side
Category	Earthen Levee
Item	Vegetation
USACE revegetation site photo spring 2012.	
johngw_s_20120419_721.jpg

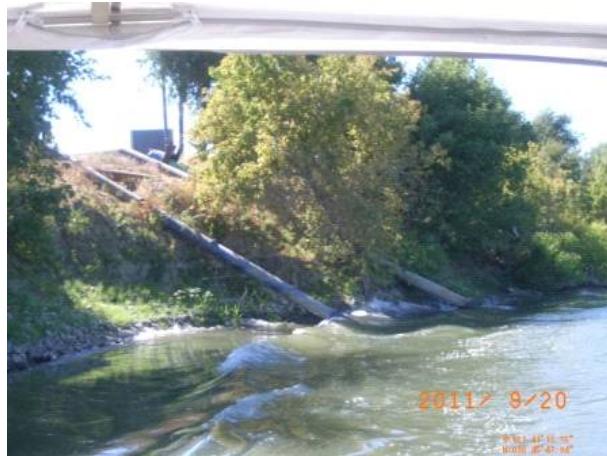
johngw_s_20120313_236.jpg

46	4.65	4.86	Supplemental USACE Erosion Survey		WS M Ma	Inspector Comments: 2009 - Erosion into the levee toe. Some cobbles have been dumped into the erosion pockets. 2010 - Old cobble site starting to unravel. 2011: No observed change. [2011 Site ID: SAC_85-4_R]	38.763486 ° -121.687567 °	38.763313 ° -121.684038 °	Y	DWR ID: DWR_NA0022_01_s_2012_4	
47	5.60	5.65	Earthen Levee	Encroachments	LS A/W En	BU : Buildings	38.759620 ° -121.673903 °	38.759412 ° -121.673167 °	Y	DWR ID: DWR_NA0022_01_s_2012_1	
48	5.76	5.86	Supplemental USACE Erosion Survey		WS M Ma	Inspector Comments: 2006 - Approximately 18 to 20 ft of bank near levee at the corner of the levee and the Freemont Weir. Vertical bank with undercutting/mass failure. 2007 - Staked at top of bank for monitoring. 2011: Site has become significantly worse with more of the toe and lower bank eroded. Many trees have fallen since last year. [2011 Site ID: SAC_83-9_R]	38.758948 ° -121.669103 °	38.759390 ° -121.667500 °	Y	DWR ID: DWR_NA0022_01_s_2012_5

USACE 2011 Photo #1

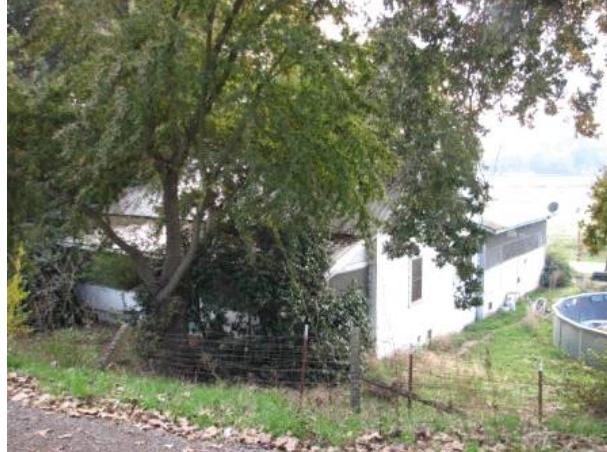
Levee Mile Report Line	47
Start Levee Mile	5.60
End Levee Mile	5.65
Location	Land Side
Category	Earthen Levee
Item	Encroachments
The house and landscape are in the easement of the levee. Fall 2011	
johngw_s_20120313_232.jpg

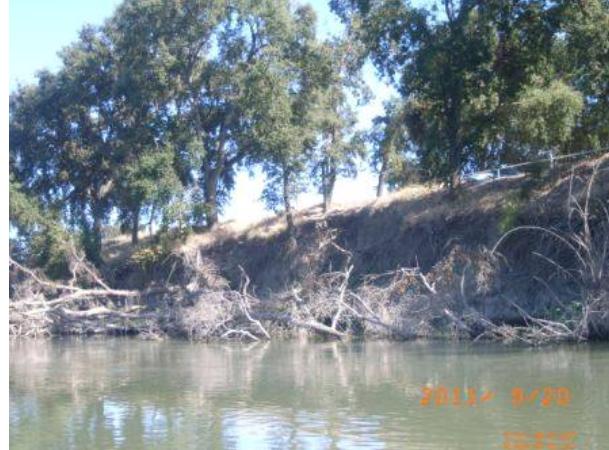
Levee Mile Report Line	48
Start Levee Mile	5.76
End Levee Mile	5.86
Location	Water Side
Category	Supplemental
Item	USACE Erosion Survey
USACE 2011 Photo #3	johngw_s_20120313_241.jpg
